# RAG-POT

*Kennebec River Sail & Power Squadron's monthly newsletter  
Unit of the United States Power Squadrons*

# Relocating Nav Instruments

by Gary Bain

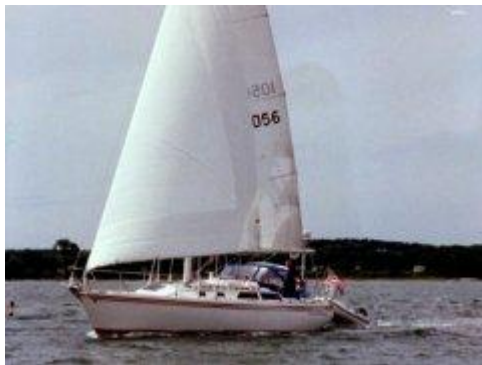
When we purchased our Catalina 36 in July 2003 it had the radar mounted off the shelf adjacent to the chart table so that it was suspended out over the chart table. The VHF radio was mounted on this shelf adjacent to the chart table chair. (Long reach from the cockpit). I was able to turn the radar enough to be able to see it if I leaned over the port coming and looked down through the companion way. Of course I managed to get myself off course because I was holding on to the wheel while leaning over "duh". Needless

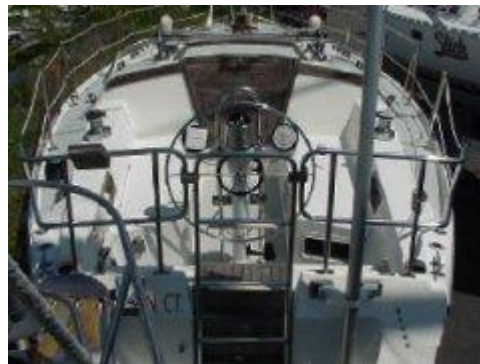
to say, I was not going to be able to put up with this for the long haul. I also was hesitant to make immediate changes until I became somewhat comfortable with the handling of the boat. I only wanted to rearrange and install once. On previous boats many changes were made on the fly leaving telltale holes, wiring, etc. After the first season I decided on what I was going to do with the instruments. I had the original knot meter and a replaced depth sounder mounted on the pedestal which is another phenomenon I find myself wondering about. (I have one friend with a Catalina 34 in which one needs a stepstool to see over the helm.) I found on my boat I had to lean back to see the instruments and if the sun were right I had to be sitting down to read either KM or DS.

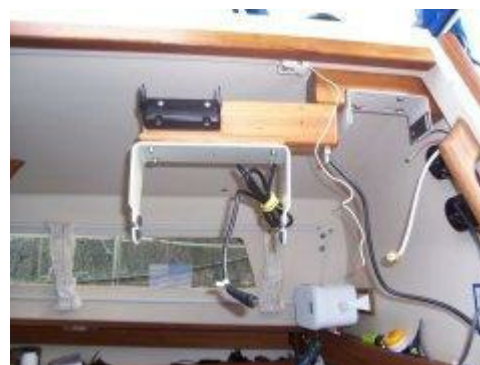
Over the winter of 2004 I got busy and made several changes. I managed to design and make a wooden bracket that would hold a new GPS chart plotter, the Radar screen, and the radio near the companion way, so that I could swing the radar and chart plotter out and put it out of the way when not needed. I tucked the VHF radio into this bracket as well and I am pleased with the outcome. I also moved the KM and DS to the starboard bulkhead. My wife

wanted me to make sure that we did not have the usual rat's nest of wiring exposed. I managed to route all the wiring under the shelf on the starboard bulkhead and brought it up

alongside the companion way (kept the rats nest to a minimum.) She has approved this arrangement and it is respectfully neat. Operating this past summer has been a pleasure. I can see everything from the helm.

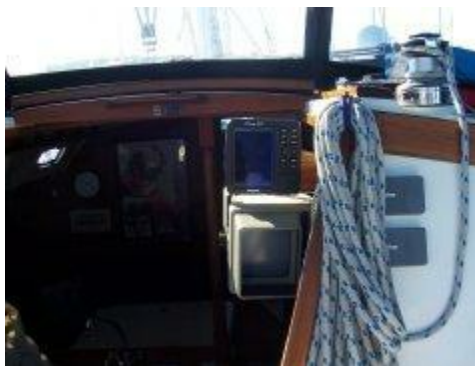
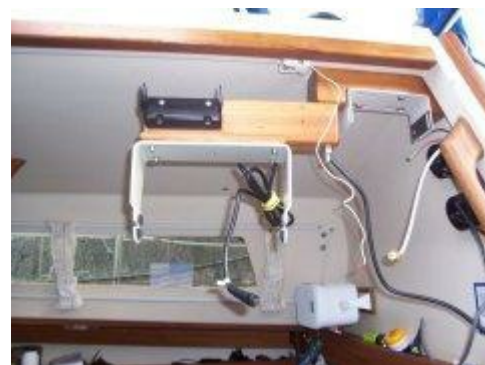
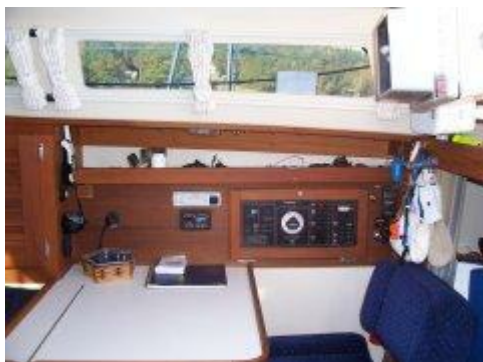
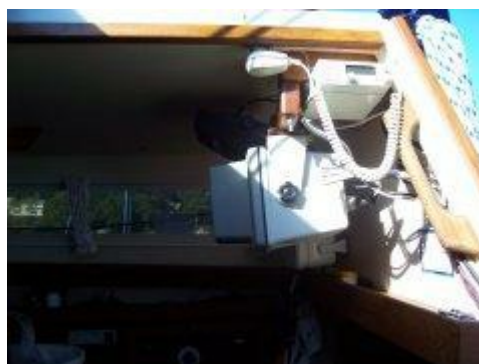
I also managed to straighten out the Nav station. I installed my portable GPS and a handheld compass approximately where the radar was mounted. I also managed to straighten out the Nav station. I installed my portable GPS and a handheld compass approximately where the radar was mounted. I moved the AM-FM radio into the panel adjacent to the Nav station, along with a Link 20 monitor (another article for another time). As I said earlier, my goal was to make these relocations and installations a onetime event. So far it looks like I will be able to stick to my goal.
